# Diagnosing common gear-drive problems

**If your mechanical conveyor's gear drive is experiencing excess wear or premature gear failure but you aren't sure why, inspecting the gear-tooth wear patterns can help you diagnose the cause. This article lists some common symptoms of abnormal gear wear and provides general tips for how to solve gear-drive problems.**

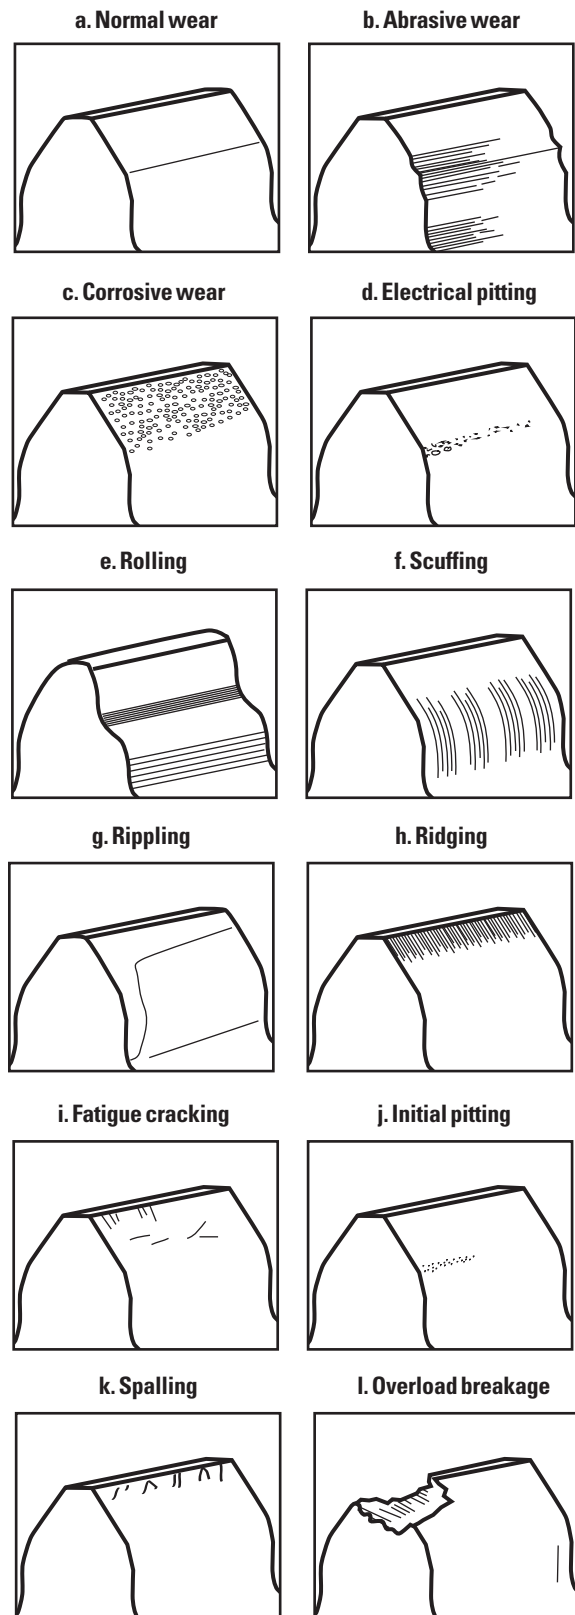
**Figure 1**

**Gear wear patterns**

**Abrasive wear.** Abrasive wear, as shown in Figure 1b, is often caused by small, hard particles from worn gear teeth or the surrounding environment contaminating the gear drive's lubricating oil. These particles scratch the gear teeth as the gears engage each other during operation. Maintaining clean, particle-free lubricating oil can help prevent abrasive wear. Follow these steps to remove abrasive contaminants from your gear drive's lubricating oil:

**Corrosive wear.** Corrosive wear, as shown in Figure 1c, occurs when acid comes into contact with the gear teeth, causing a chemical reaction with the metal. Corrosive wear is usually identified by a stained or rusty appearance on the gear surface and can be caused by system overload or improper maintenance procedures. If your gear drive is showing corrosive wear, check with the drive supplier for the recommended maintenance procedures and lubricant type. You may need to perform more frequent oil changes or upgrade to an extreme-pressure lubricant. If the system is overloaded, you'll need to either reduce the load or upgrade the drive.

**Electrical pitting.** Electrical pitting, as shown in Figure 1d, can occur when electric discharges arc across the film of oil between mating gear teeth, causing small indentations to form on the tooth surface. These electric discharges can be caused by improper electrical system installation and grounding or static electricity generated by the conveying process. If your process is generating static electricity, install grounding straps from the conveyor to rigid electrical or pneumatic piping to dissipate the electrostatic charge. Also, when welding in the area, be sure to place the ground clamp so that the current doesn't flow through the gear drive and arc between the gear teeth.

**Rolling and scuffing.** Rolling (also called peening), as shown in Figure 1e, is the deformation of metal on the active portion of the gear tooth caused by high-contact stresses. This displacement of surface material creates horizontal grooves along the tooth face and causes burrs to form at the gear tooth's tip.

Scuffing is severe abrasion that causes metal from one gear tooth surface to transfer to another tooth due to welding and tearing action during operation. Scuffing can be identified by vertical lines on the tooth surface, as shown in Figure 1f. Scuffing is generally localized in patches where the meshed tooth surfaces are mismatched or misaligned.

**Plastic flow failure.** Plastic flow failure (also called rippling or ridging), as shown in Figures 1g and 1h, is a type of deformation of the gear-tooth surface caused by high levels of sliding or rolling stress between mating gear teeth. Plastic flow failure typically affects gears made of softer metals but can also occur in case-hardened gears. Heavily loaded worm drives and hypoid-and-pinion gear drives, which combine high compressive stress with high-contact, low-velocity sliding action, are most-frequently affected. Plastic flow failure is typically caused by improper lubrication or excessive operating loads and can become dangerous in advanced stages.

Uneven gear-tooth surfaces or shock loads can create local areas of high stress at the gear-tooth surface. This can lead to surface fatigue failures such as initial pitting, as shown in Figure 1j, and spalling, as shown in Figure 1k. Spalling is similar to pitting, but material continues to break away from the edges of the pits, forming large, irregular, interconnected voids in the tooth surface.

**Gear-tooth breakage.** Premature gear-tooth breakage, as shown in Figure 1l, can be caused by contaminants entering the gear drive, overload, or shock load. If outside contamination has caused the breakage, remove the contamination and cover the drive to prevent further damage. If the breakage was caused by overload or shock load and eliminating the overload or shock load condition isn't possible, consider upgrading the drive. You can replace the drive with one that uses wider-faced gears or, if your drive's gears use a 14.5-degree pressure angle, switch to a drive with gears that use a 20-degree pressure
